DEPARTMENT OF TRANSPORTATION**DIVISION OF ENGINEERING SERVICES**

Contract #: 04-0120F4Cty: SF/ALA Rte: 80 PM: 13.2/13.9File #: 13.28**WELDING INSPECTION REPORT****Resident Engineer:** Pursell, Gary**Address:** 333 Burma Road**City:** Oakland, CA 94607**Report No:** WIR-011898**Date Inspected:** 09-Feb-2010**Project Name:** SAS Superstructure**OSM Arrival Time:** 1000**Prime Contractor:** American Bridge/Fluor Enterprises, a JV**OSM Departure Time:** 1630**Contractor:** Oregon Iron Works Clackamas, Or.**Location:** Clackamas, OR

CWI Name:	M. Gregson, J. Salazar, G. Mundt			CWI Present:	Yes	No
Inspected CWI report:	Yes	No	N/A	Rod Oven in Use:	Yes	No N/A
Electrode to specification:	Yes	No	N/A	Weld Procedures Followed:	Yes	No N/A
Qualified Welders:	Yes	No	N/A	Verified Joint Fit-up:	Yes	No N/A
Approved Drawings:	Yes	No	N/A	Approved WPS:	Yes	No N/A
				Delayed / Cancelled:	Yes	No N/A
Bridge No:	34-0006			Component:	Hinge K Pipe Beams

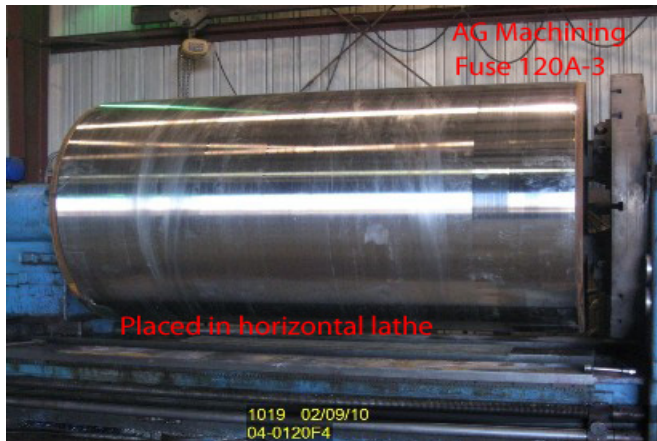
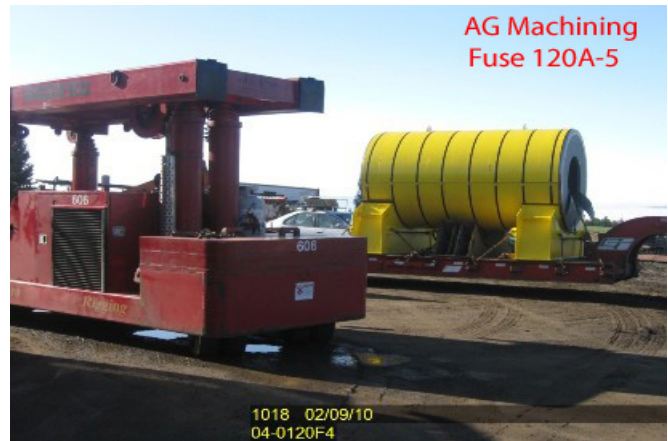
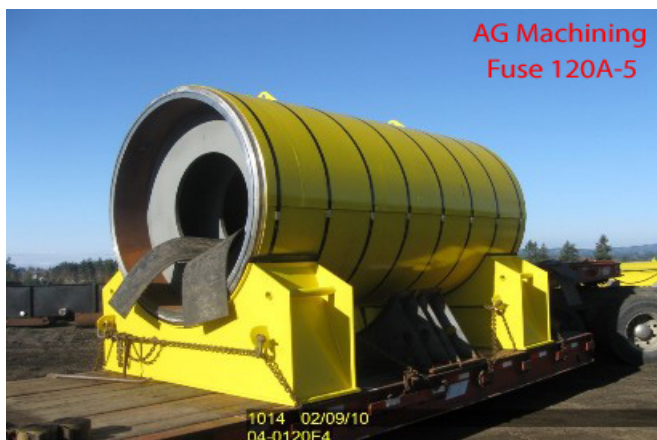
On this date, the QA Inspector arrived at AG Machine shop, to witness OIW switch out Fuse 120A-5 and Fuse 120A-3, for final machining. The QA Inspector arrived at approximately 1000 and witnessed Metro Machinery Rigging picking up the Fuse 120A-5, from the horizontal lathe. The QA Inspector witnessed Metro place two slings around the Fuse and attach to a forklift, with a hydraulic lifting boom. The QA Inspector witnessed Metro Machinery then placing this Fuse, on a flatbed trailer. The QA Inspector noted that two saddles with rubber cushions had been previously placed on the flatbed trailer. The QA Inspector then witnessed Metro personell using two come-a-longs to anchor the Fuse to the trailer. The QA Inspector witnessed Metro Personell placing rubber cushions on the interior of the Fuse and securing with more come-a-longs. The QA Inspector noted that the Fuse 120A-5 was being transferred back to OIW, after final machining and 100% penetrant testing was complete and OIW accepted. The QA Inspector then witnessed Metro picking up the Fuse 120A-3 from a separate trailer, utilizing two chokers. The QA Inspector then witnessed Metro placing the Fuse, into the horizontal lathe. The QA Inspector noted that the AG Machinist tightened the lathe chucks, to secure the Fuse in place. The QA Inspector noted that this Fuse 120A-3 had previously been at AG and Final "Trial" machining had been performed to within 1.5 mm of the final tolerance, per the contract requirements. The QA Inspector noted that the contract requires an outside diameter of 1920 mm (+/- 1mm). See attached pictures below.

The QA Inspector then met with the AG Machinist and AG explained that OIW Machinist Matt Ackerson, had previously arrived on 2/5/10 to perform the FARO laser measurements, on the Fuse 120A-5. AG explained that the final length of the Fuse was measured at 3516 mm, with a tape measure and FARO measurement was also 3516 mm. The QA Inspector later notified Lead QA Inspector Joe Adame that OIW had previously performed the FARO measurements on the Fuse. QA Inspector Adame spoke with OIW PM Bill Pender and Mr. Pender explained that the following FARO Laser measurements were recorded: Finished outside diameter of 1920.88 mm and the cylindrical deviation was measured at .28 mm. QA Inspector Adame explained that Mr. Pender had provided a copy of the FARO testing results. The QA Inspector noted that the above mentioned FARO measurements, on this Fuse 120A-5, appeared to be in compliance with the specified tolerances, per the contract requirements.
